Materials Report 78-E ✓

**THE RESISTANCE OF HY130 STEEL TO
ENVIRONMENTAL CRACKING IN SEA WATER**

December 1978

Research and Development Branch

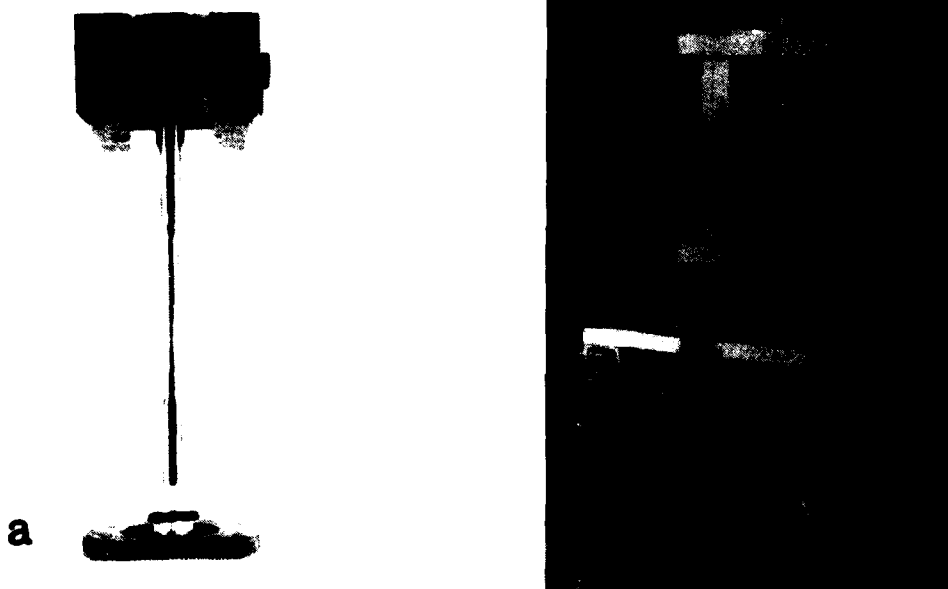
Figure 2.

- a. DREP tensile specimen used for environmental crack initiation tests.
- b. DREP environmental tensile testing machine.

Crack initiation studies were made on smooth tensile specimens as shown in Figure 2a. The specimens were machined with the long axis transverse to the plate primary rolling direction and, in the case of welded specimens, transverse to the weld. Gauge sections were ground to an 8 μ inch finish. After degreasing with hexane, the specimen was immersed in continuously flowing natural sea water at 8° - 12°C with a uniaxial (within $\pm 2\%$) tensile load applied by means of a lever system as shown in Figure 2b.
